# Indirectly Inspecting PEM Nut Threads

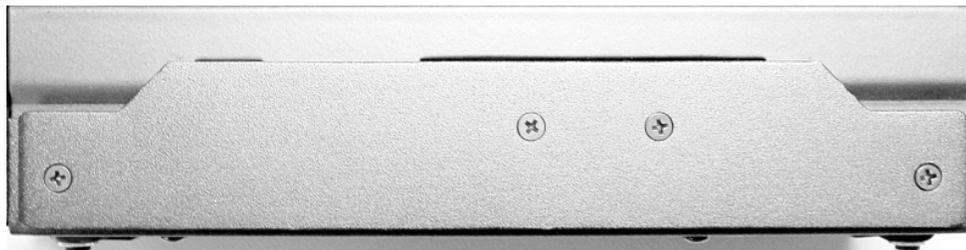
1. After referring to the photo below and while using the proper tool, remove just the leftmost screw securing the original factory heatsink. (This is **the screw adjacent to the antenna connector.**)

*Photo courtesy of Adrian Ryan, 5B4AIY*

2. **Thoroughly inspect its threads** under a bright light using a 7X jeweler’s loupe (preferably) or a magnifying glass. **They should be black!** If they are shiny, it means the black oxide coating has separated from the screw and is most likely contaminating the internal threads of the PEM nut that’s machined into the case! *Even the tiniest amount of this coating can cause problems.*
